Burbank Water and Power

# WILDFIRE MITIGATION PLAN

2021 DRAFT

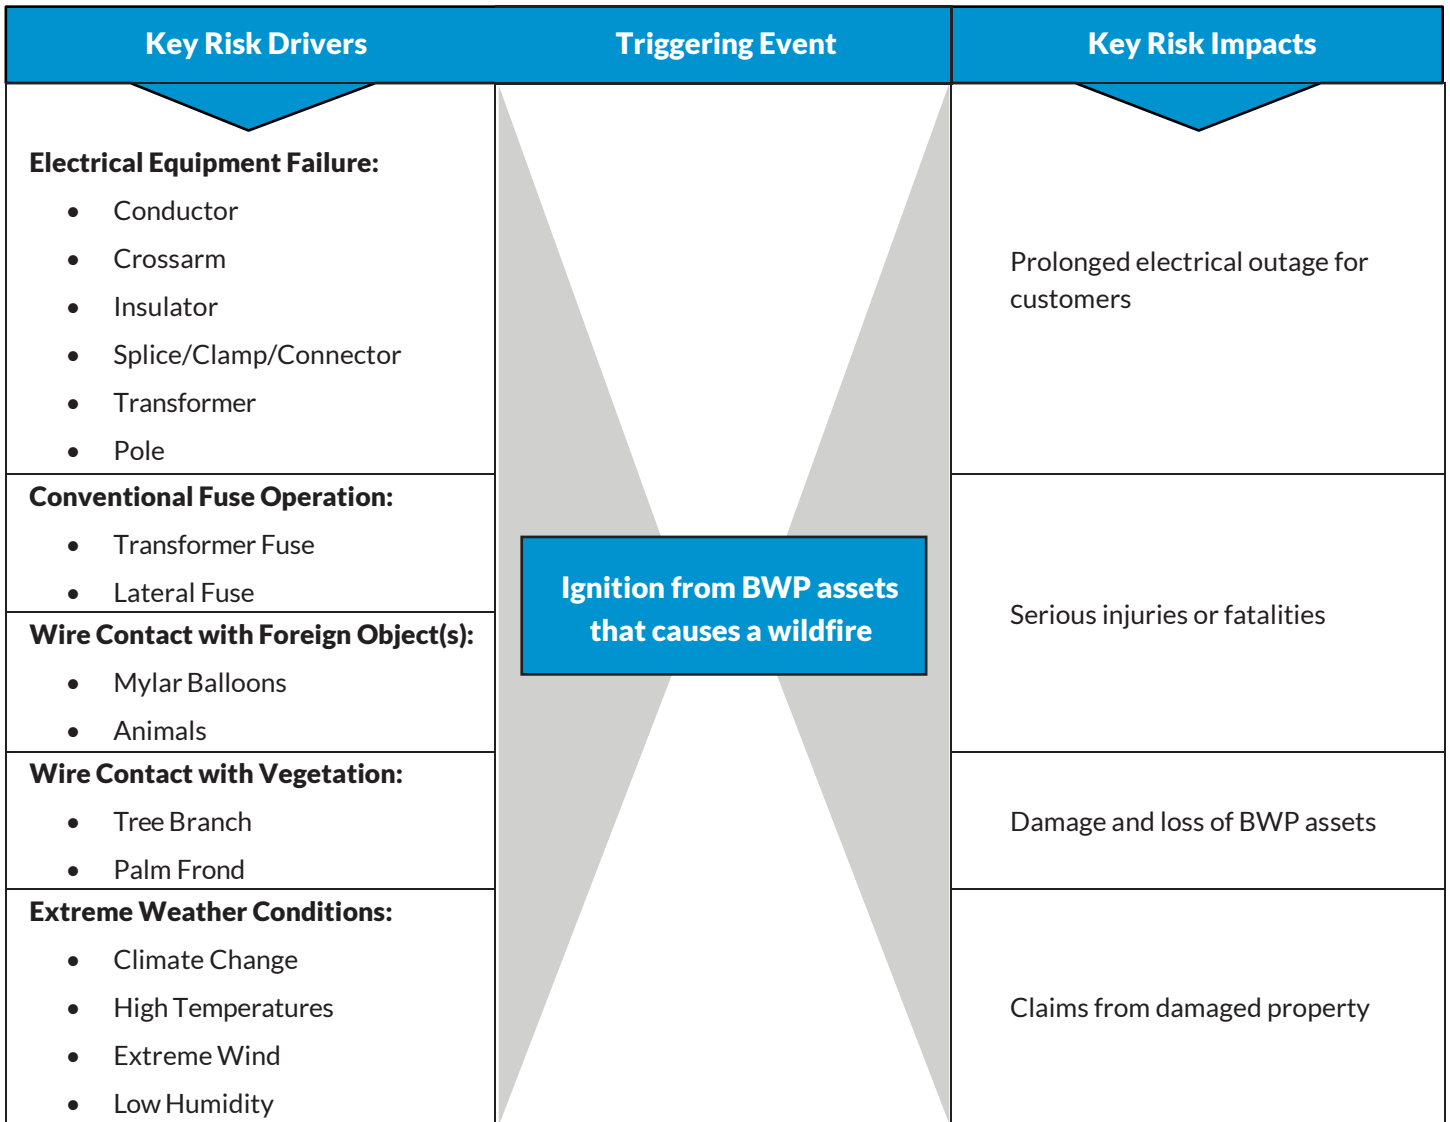
**Figure 3 – BWP’s Wildfire Risk Bowtie**

The risk of a vegetation ignition and potential for an uncontrollable wildfire caused by BWP electrical facilities is related to the type of vegetation (fuel bed) within its vicinity, the local/regional weather patterns, and the potential for a failure of BWP's equipment. For example, areas that include uninterrupted, natural (unmaintained) vegetation present a risk of ignition from ongoing operational activities or equipment failures. When the area also includes weather conditions that result in periodic high wind and low humidity, the wildfire risk is significantly enhanced. Both of these weather conditions can occur in BWP's Tier 2 HFTD area. A bow tie analysis was conducted to identify these risk drivers as well as their potential resulting impacts. Figure 3 provides the risk bow tie diagram, which summarizes the assessment process.

Risk drivers are important to identify because they are the primary ways in which BWP electrical facilities could result in a catastrophic wildfire. The center of the bow tie chart is the triggering event, which is an ignition caused by a BWP asset resulting in a catastrophic wildfire. During the wildfire threat assessment, five categories were identified as potential drivers for causing fire ignitions:

1. Electrical equipment failure;
2. Conventional fuse operation;
3. Wire contact with foreign object(s);
4. Wire contact with vegetation; and
5. Extreme weather conditions.

If one of the risk drivers listed above were to occur, resulting in a wildfire ignition caused by BWP electrical facilities, there could be potential consequences for BWP as presented on Figure 3.

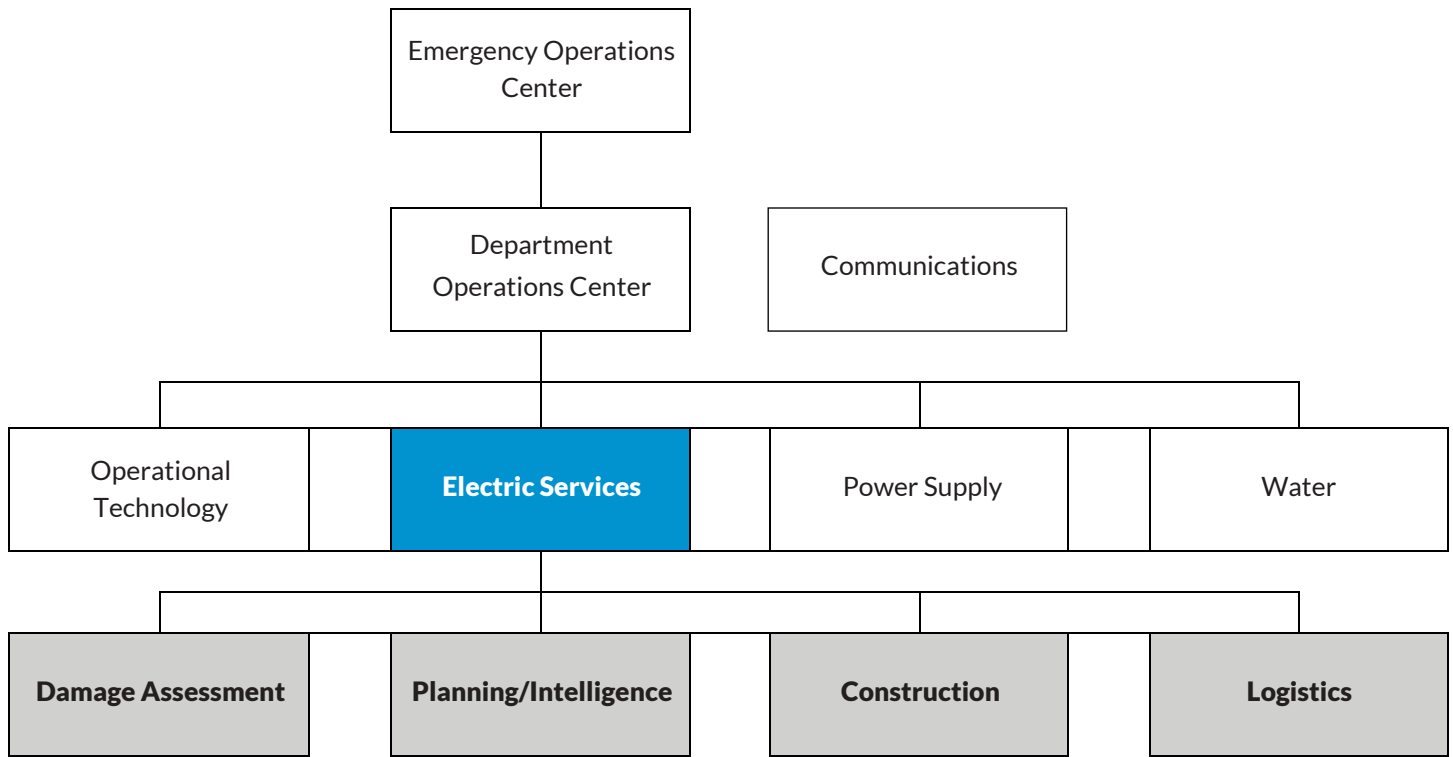
**Figure 8 - BWP Emergency Response Teams' Organization**

The Electric Services Response Team is comprised of four response teams: Damage Assessment, Planning/Intelligence, Construction, and Logistics as presented in Figure 7. The responsibilities of each response team are described in Table 10 below.
