Burbank Water and Power

WILDFIRE MITIGATION PLAN

December 2020 *Rev.1*

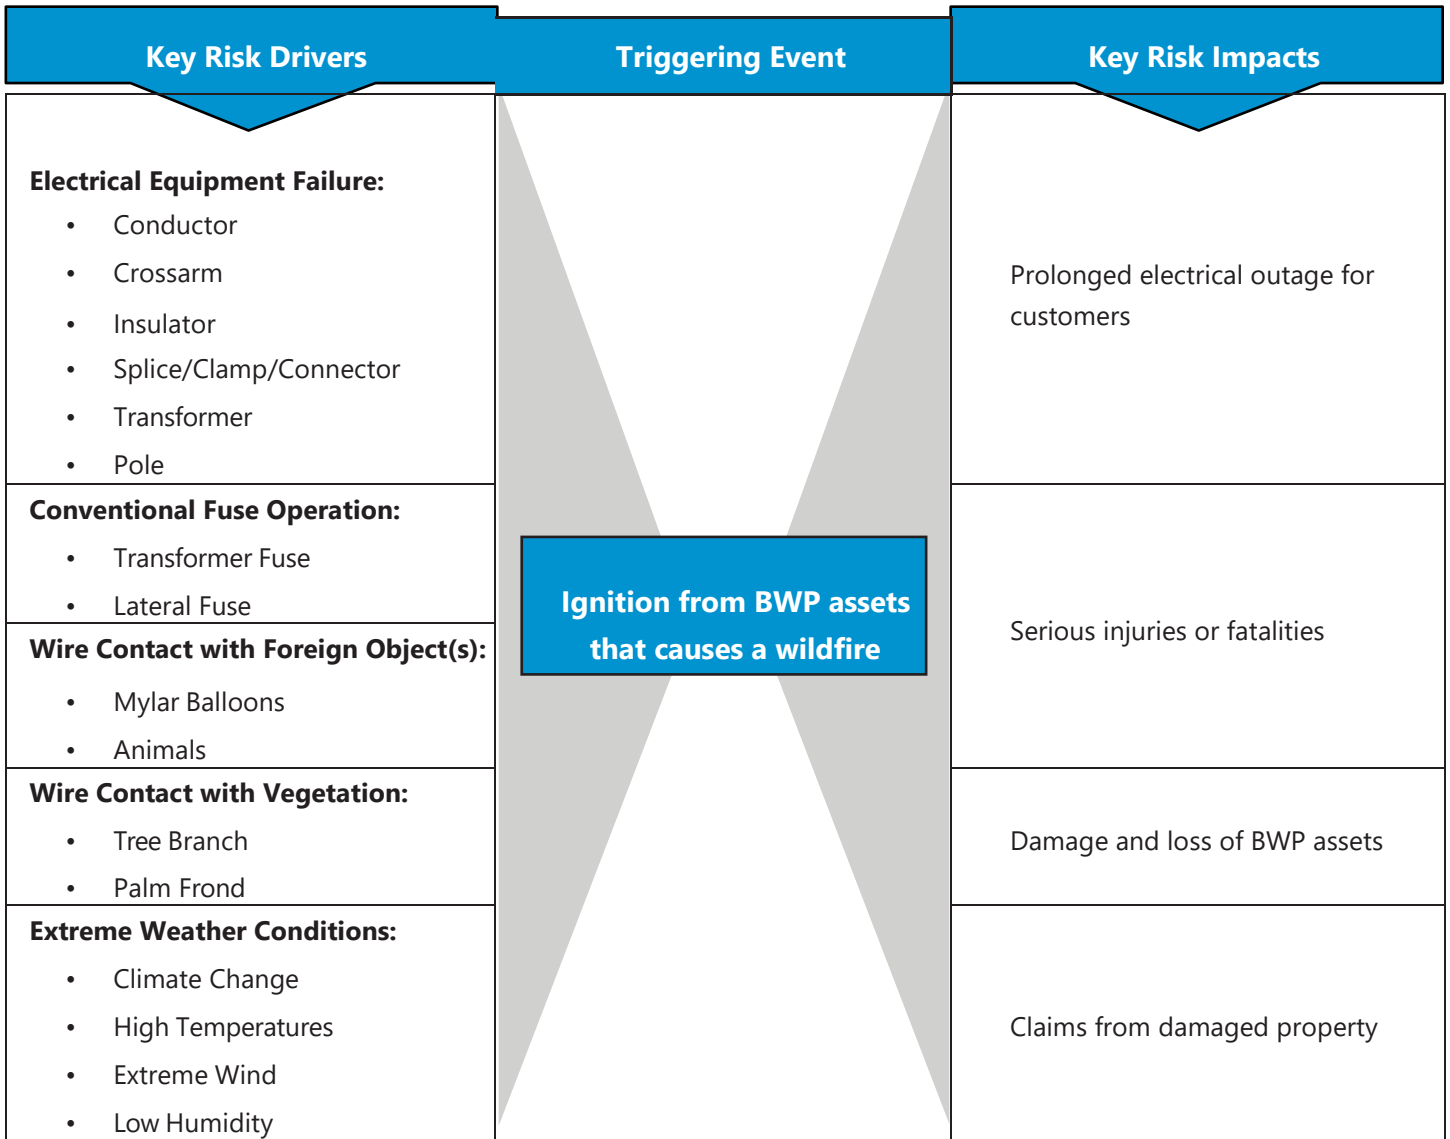
Figure 3 – BWP’s Wildfire Risk Bowtie

The risk of a vegetation ignition and potential for an uncontrollable wildfire caused by BWP electrical facilities is related to the type of vegetation (fuel bed) within its vicinity, the local/regional weather patterns, and the potential for a failure of BWP's equipment. For example, areas that include uninterrupted, natural (unmaintained) vegetation present a risk of ignition from ongoing operational activities or equipment failures. When the area also includes weather conditions that result in periodic high wind and low humidity, the wildfire risk is significantly enhanced. Both of these weather conditions can occur in BWP's Tier 2 HFTD area. A bow tie analysis was conducted to identify these risk drivers as well as their potential resulting impacts. Figure 3 provides the risk bow tie diagram, which summarizes the assessment process.

Risk drivers are important to identify because they are the primary ways in which BWP electrical facilities could result in a catastrophic wildfire. The center of the bow tie chart is the triggering event, which is an ignition caused by a BWP asset resulting in a catastrophic wildfire. During the wildfire threat assessment, five categories were identified as potential drivers for causing fire ignitions:

If one of the risk drivers listed above were to occur, resulting in a wildfire ignition caused by BWP electrical facilities, there could be potential consequences for BWP as presented on Figure 3.
